NORWEGIAN SEISMIC ARRAY

NORSAR Report No 32
Budget Bureau No 22-RQ293

Field Maintenance Report

1 January - 30 September 1971

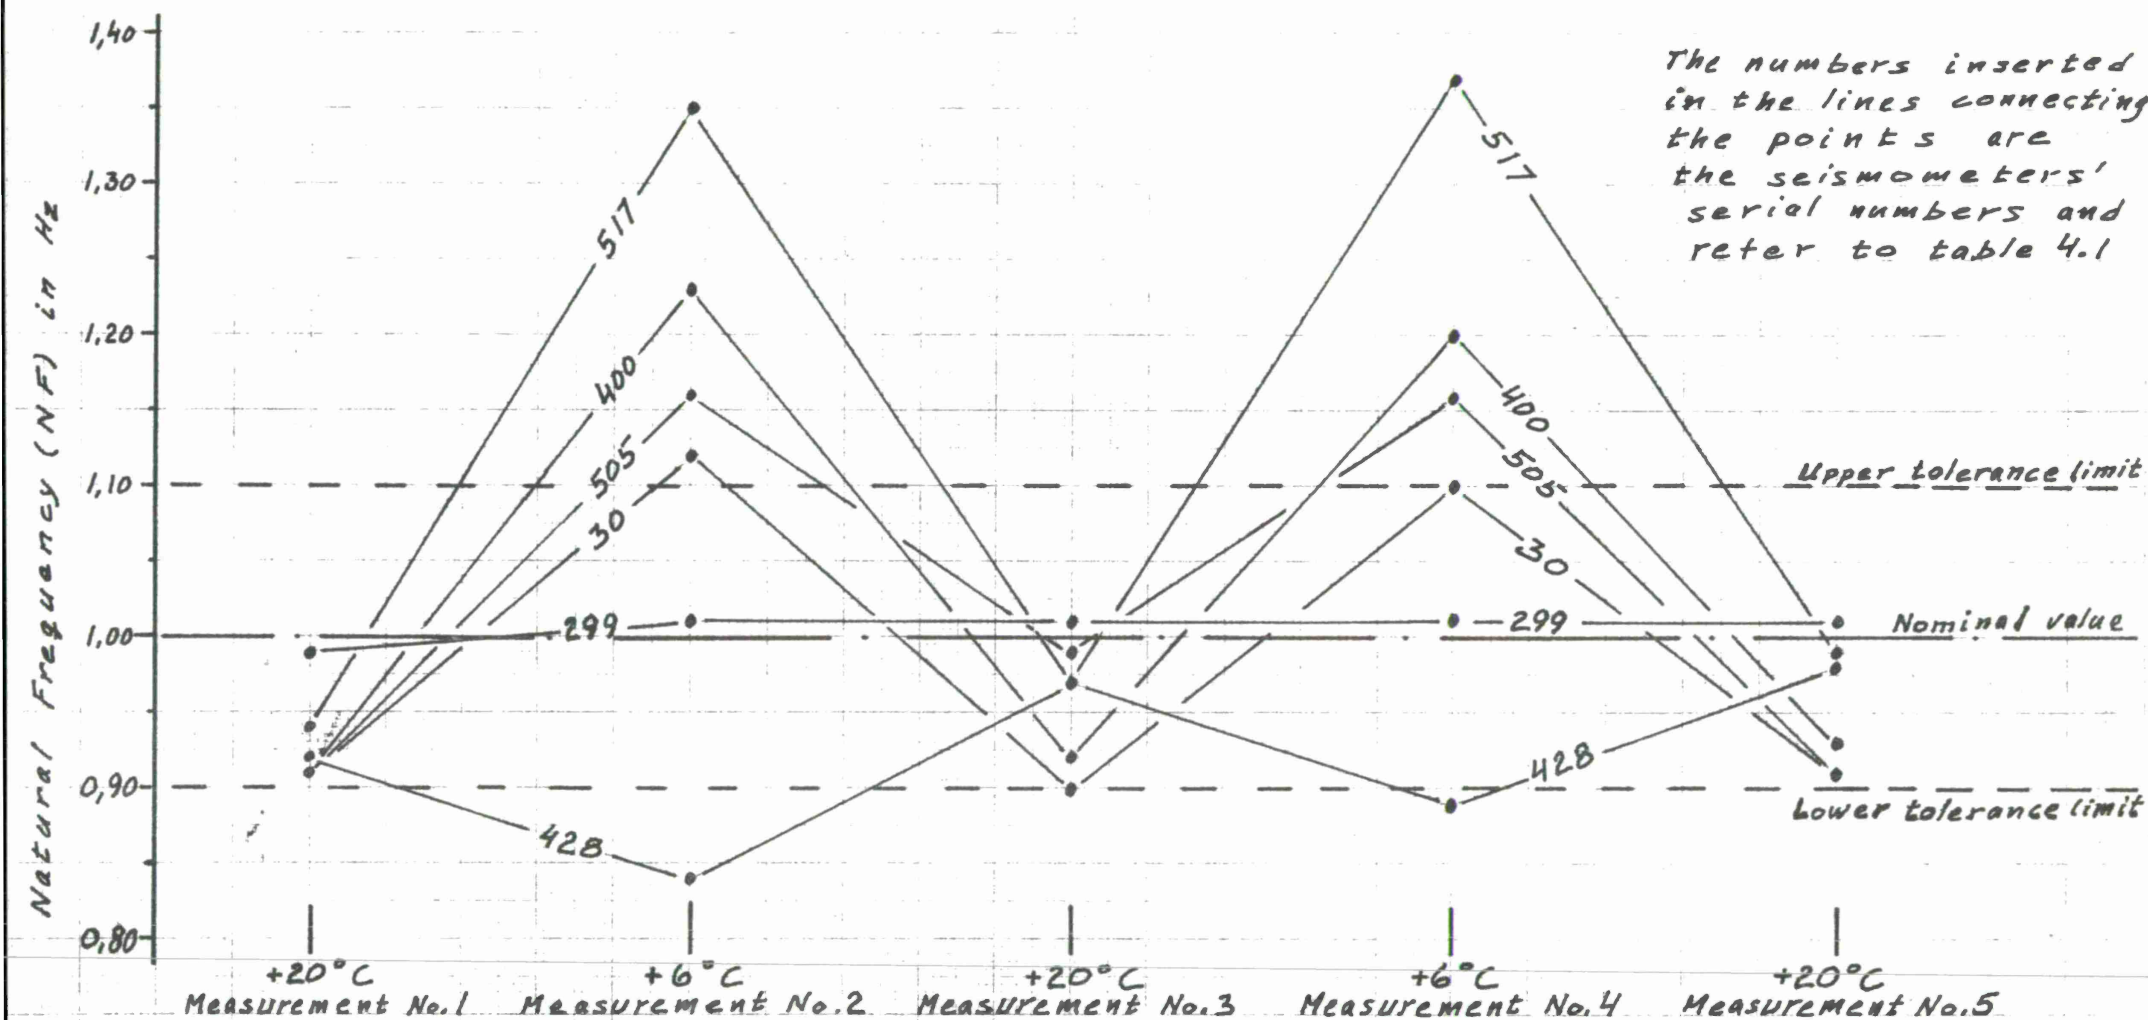
Figure 4.5 Natural Frequency of SP-seismometers in relation to environmental temperature.

The variations in NF with changing temperature and the spread between the various seismometers were about as we had experienced before. But in addition this test showed us, with the uncertainties around the test taken into account, that the NF seems to follow the temperature fairly steadily through the cycles. In other words each individual seismometer seems to end up with about the same NF at the same temperature after a temperature cycling of this nature which should be fairly realistic.

The normal working temperature at the MC would be +20°C and + 6°C would be near the operating temperature for the seismometers in the bore holes. Because of the great variation in NF between these two temperature levels we felt that it would be most correct to adjust the seismometers at a temperature as near as possible to the operating temperature. This would be inconvenient and time consuming at the MC, since the seismometers would have to be brought back and forth between the temperature chamber and the testbed. The conditions at the temperature chamber are not stable enough for adjustment of the seismometers. So, for the time being, with great demand for seismometers in the field, we decided to do the adjustments in the OlA LPV, whereafter the seismometers could be brought (carefully) to the Brumunddal Field Base for cable fitting and potting.

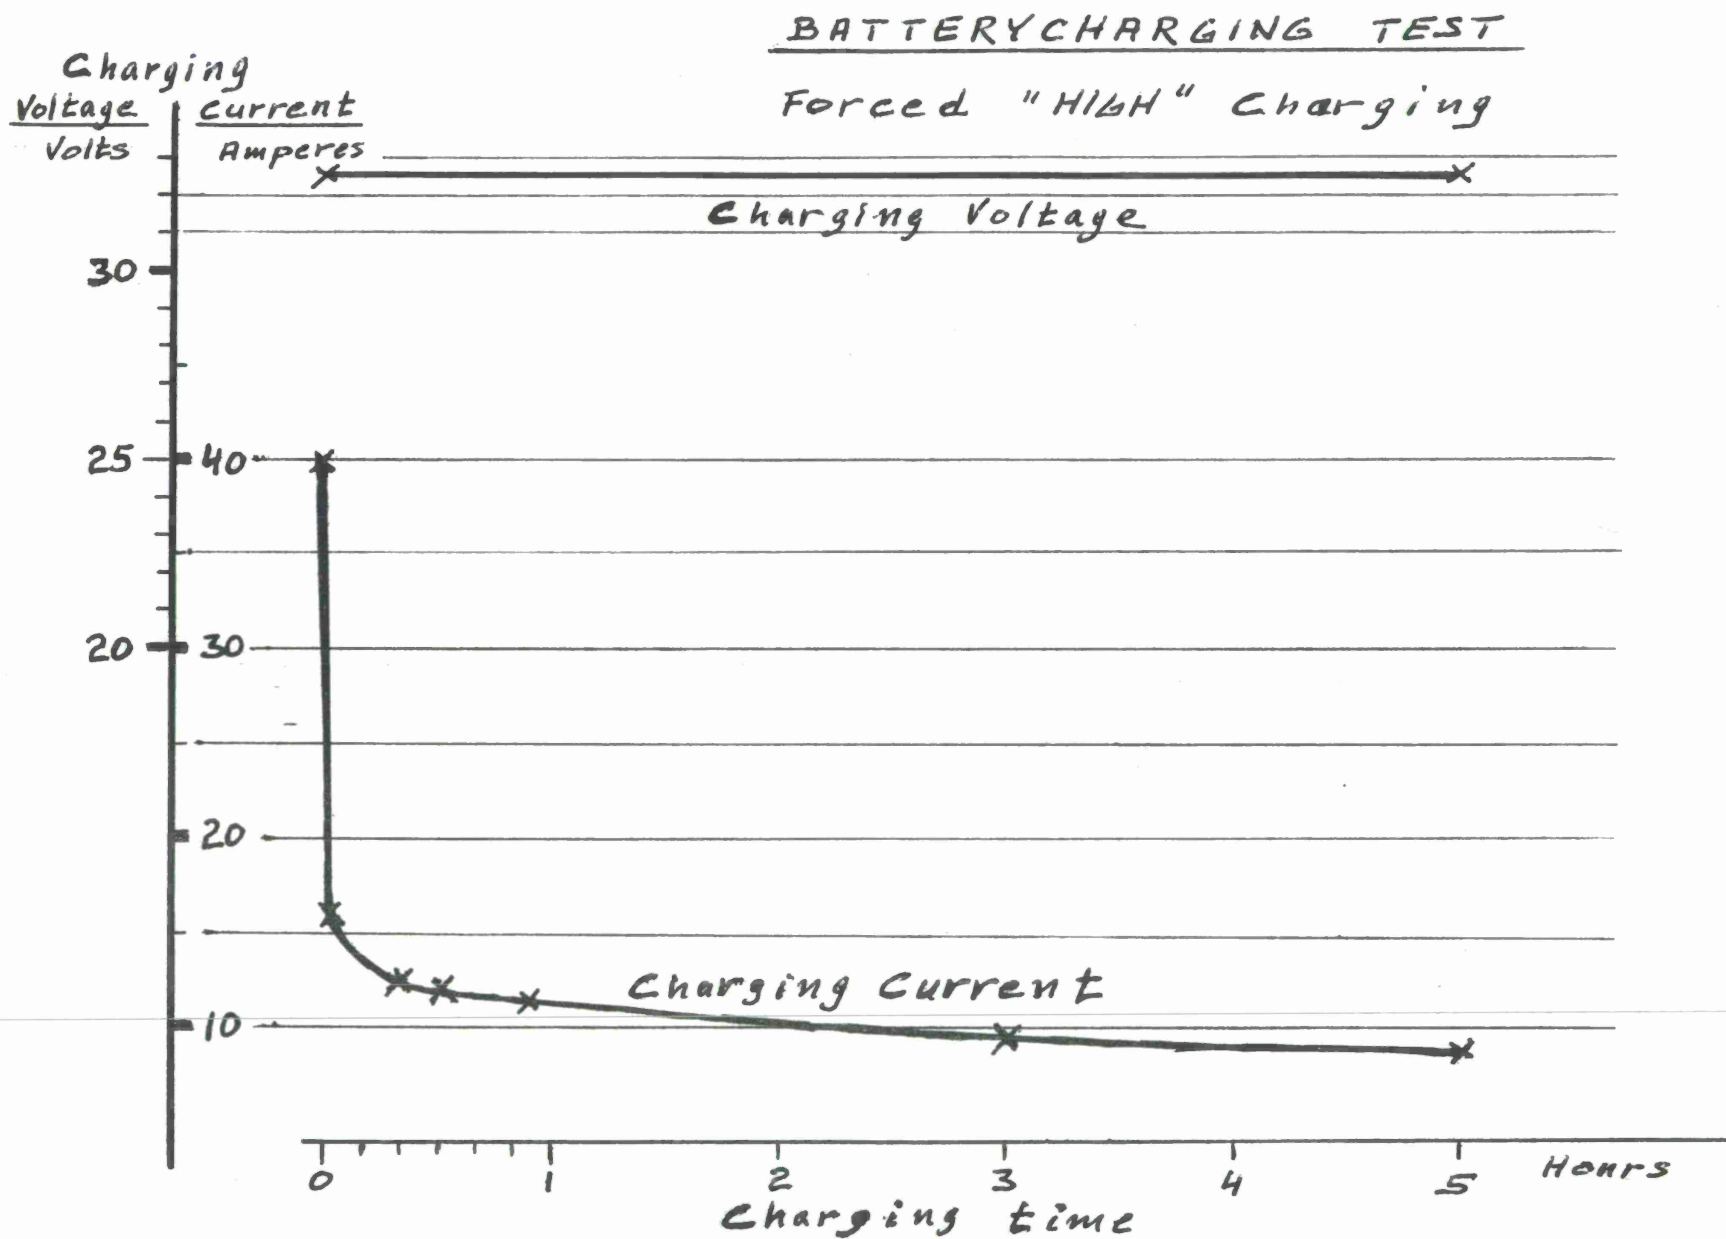
Figure 6.3 Forced "HIGH" Charging.

Gassing started 3 - 4 minutes after start of the test and was increasing towards the end of the period. The electrolyte level did not decrease noticeably during the test, however.

The regulating zener diodes N1, N2 and N3 on the circuit card U3 got very hot during this test, and because they were placed onto the card without any air gap, the card burned somewhat.
